Contract #: 04-0120F4Cty: SF/Ala Rte: 80 PM: 13.2/13.9File #: 69.28**WELDING INSPECTION REPORT****Resident Engineer:** Pursell, Gary**Address:** 333 Burma Road**City:** Oakland, CA 94607**Report No:** WIR-015753**Date Inspected:** 12-Jul-2010**Project Name:** SAS Superstructure**OSM Arrival Time:** 1900**Prime Contractor:** American Bridge/Fluor Enterprises, a JV**OSM Departure Time:** 700**Contractor:** Zhenhua Port Machinery Company, Ltd (ZPMC), Changxing Island **Location:** Shanghai, China**CWI Name:** See below**CWI Present:** Yes No**Inspected CWI report:** Yes No N/A**Rod Oven in Use:** Yes No N/A**Electrode to specification:** Yes No N/A**Weld Procedures Followed:** Yes No N/A**Qualified Welders:** Yes No N/A**Verified Joint Fit-up:** Yes No N/A**Approved Drawings:** Yes No N/A**Approved WPS:** Yes No N/A**Delayed / Cancelled:** Yes No N/A**Bridge No:** 34-0006**Component:** Tower and OBG Components**Summary of Items Observed:**

WELDING INSPECTION REPORT

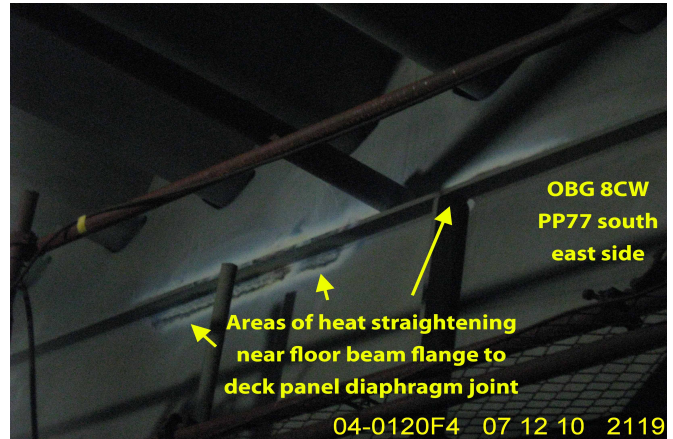
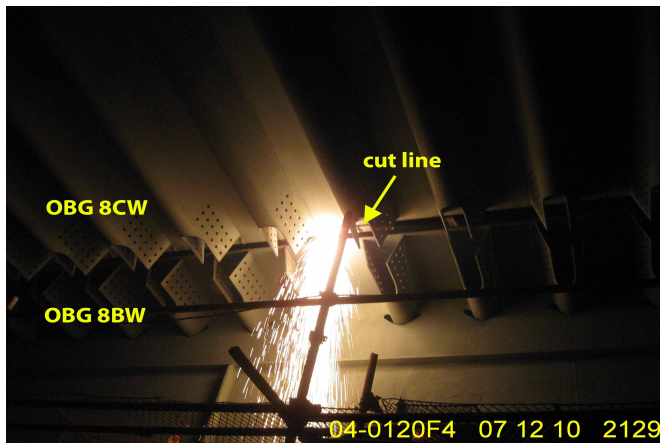
Flame cutting using automated equipment on the deck plate and bottom plate of OBG segment 8CW at the 8BW/8CW transverse joint. See photos below of these operations.
